# ***Status assessment and planning for reduction in water stress***

A case study of Pathardi village of Mokhada Taluka

***TDSC- Aroehan-Siemens CSR***

**Technology and Development Solutions Cell  
Centre for Technology Alternatives in Rural Areas  
Indian Institute of Technology Bombay  
Powai, Mumbai**

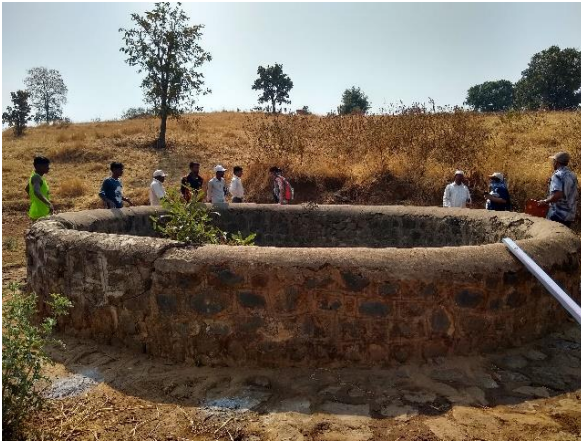
| Asset Name | Physical condition | Dimension | Water Availability | Current water level | Accessibility | | | Quality | Usage and Dependency |
|---|---|---|---|---|---|---|---|---|---|
| PDW1<br>Government | Good<br>(Physically intact)<br>Repair- A | 6.0m*6.45m | Till January end | Tanker water | 100m | 380m | Kuccha road | | Both Drinking and Domestic. 100% HH |

*Figure 4: Partial damage in PDW1 well parapet wall*

Figure 4 and Figure 5 shows the condition of wells that need repair. The severity of the damage of these assets can be checked verified by the engineers of the relevant department and accordingly measures can be taken.

From Table 1 we can extract the physical conditions of various wells. Out of that, the repairable wells should be given priority.

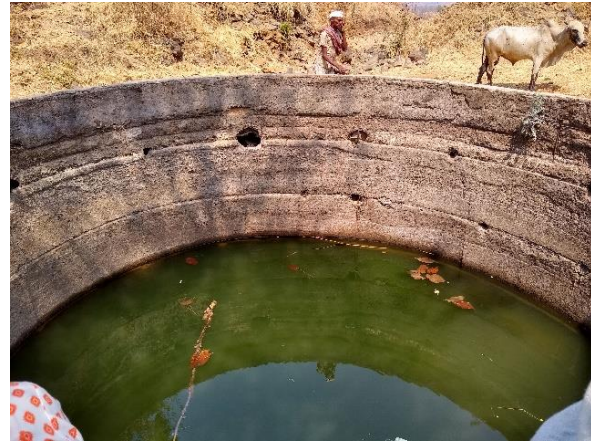
| Asset Name | Physical condition | Dimension | Water Availability | Current water level | Accessibility | | | Quality | Usage and Dependency |
|---|---|---|---|---|---|---|---|---|---|
| PDW4<br>Jalswarajya | Partially damaged,<br>Repair-A,B&C. | 6.3m*6.75m | 12 months | 1.75m | 900m | 321m | Kuccha and sloppy road | Okay | Agriculture and Drinking water when all other wells dry |

*Figure 5: Depleted condition of Parapet wall, Waterproofing layer, Platform of PDW4 well*

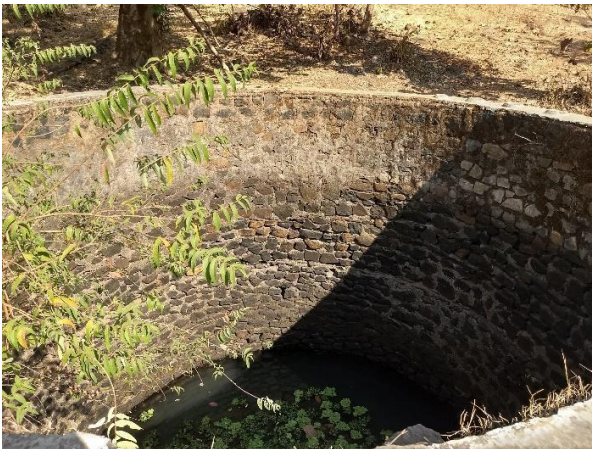
Figure 8: Water quality of PBW2 well

Figure 8 and Figure 9 shows the visual quality of water in both wells of the habitation

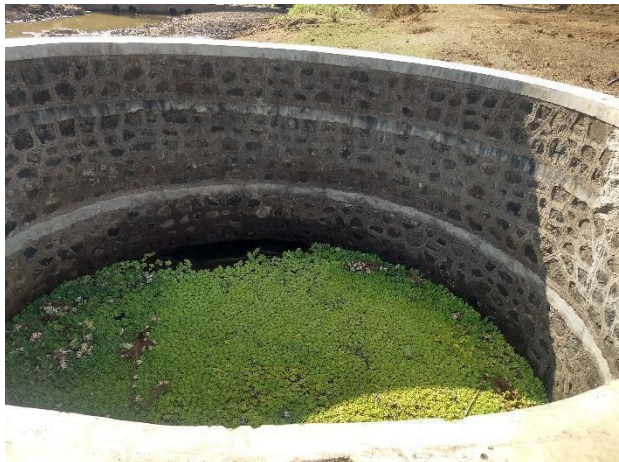
Figure 9: Water quality of PBW1 well

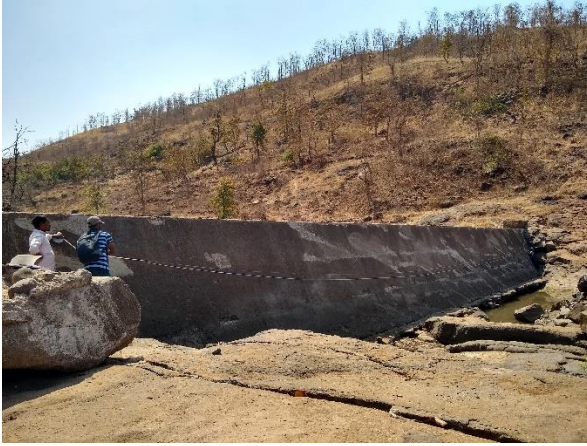
From Table 9 and Table 10 we can extract the physical conditions of various wells and storage structures. Out of that, the repairable assets should be given priority. Figure 12 and Figure 13 show fragmented condition of a CNB, thus indicating that assets need to be carefully scrutinized before considering for repair works. Not all damaged assets can be revived through repair.

*Figure 12: Damaged condition of CNB*

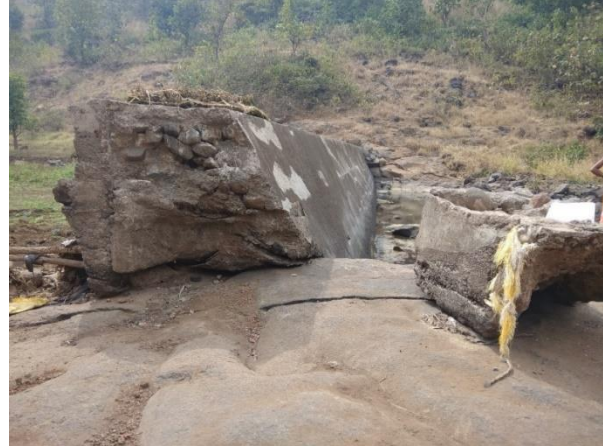
| Asset Name | Physical condition | Type | Dimension | Water Availability | Max Backwater length | Quality | Usage and Dependency |
|---|---|---|---|---|---|---|---|
| PPCB2 | Broken. Damaged- A | Normal | 38.0m*2.8m | | | | Agriculture |

*Figure 13: Fragmented condition of CNB (PPCB2)*
